Newmar RV Service Center

Nappanee, IN

98,250 sf

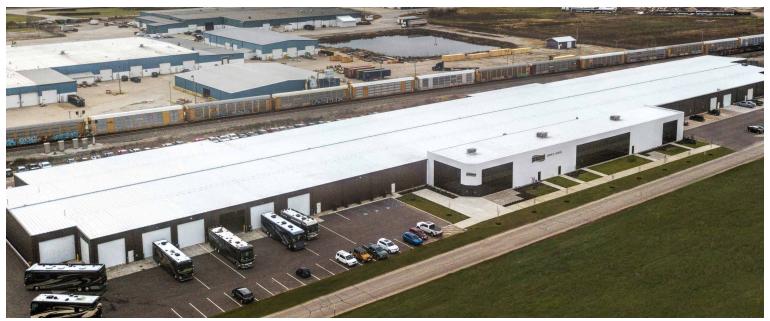
The office area is a 50′x 280′ single slope building that has a second floor mezzanine that is stress core (12″) spanning 50′. There are large sections of (curtain wall) glass supported by ABC wind beams. All of the concrete floors are polished concrete. The service center (building #1) is a 150′x 545′ gable symmetrical building. Building #2 is a 100′x 25′ gable symmetrical structure. The office building (building #3) is a 50′x 280′ single slope structure. The office has three mezzanines: (A) a 10′x 33′-6″ mezzanine with a live load of 100 psf (B) a 50′x 230′ with a 100 psf live load (C) a 25′x 6′ mezzanine with a 100 psf live load. Building #7 is a 16′x 151′ lean-to structure and building #8 is a 16′x 120′ single slope structure.
